CHRIST CHURCH DUANESBURG

EXISTING CONDITIONS REPORT

FEBRUARY 2021

JOHN G. WAITE ASSOCIATES, ARCHITECTS PLLC

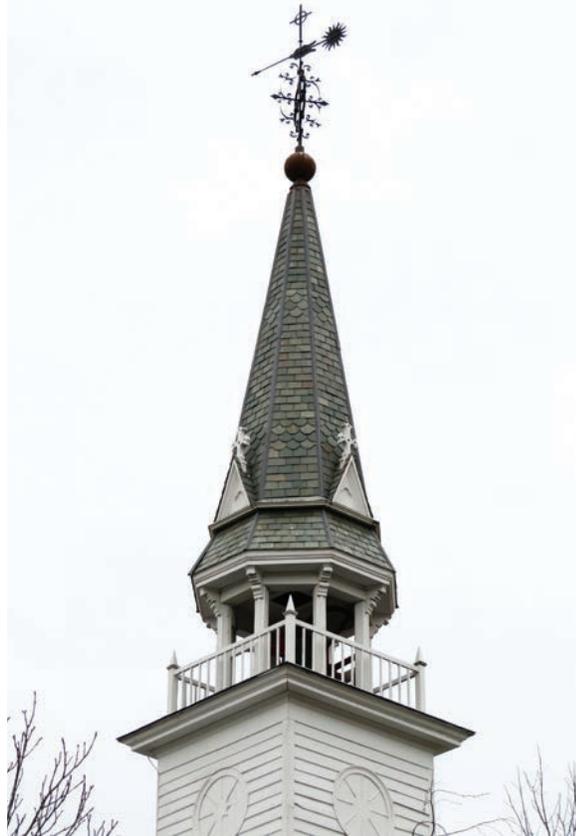
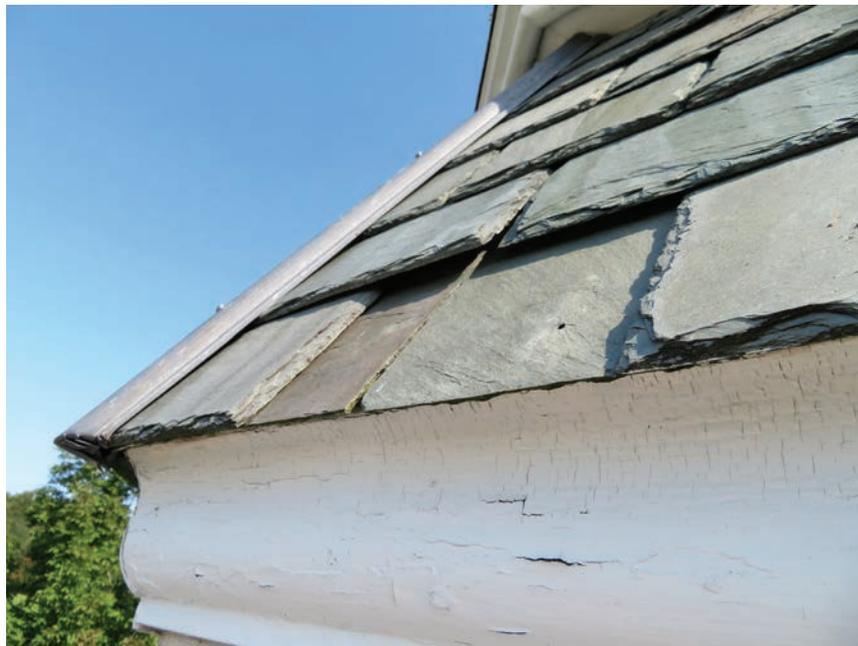
The uppermost part of the tower, the open belfry and steeple, was added to the building in the late nineteenth century and is the most recent major addition to the building. Both the belfry and the steeple underwent restoration in 2004. The existing slate roof on the spire was installed during the work, and remains in sound condition, but one slate at the eave level is missing (below). JGWA, 2020.

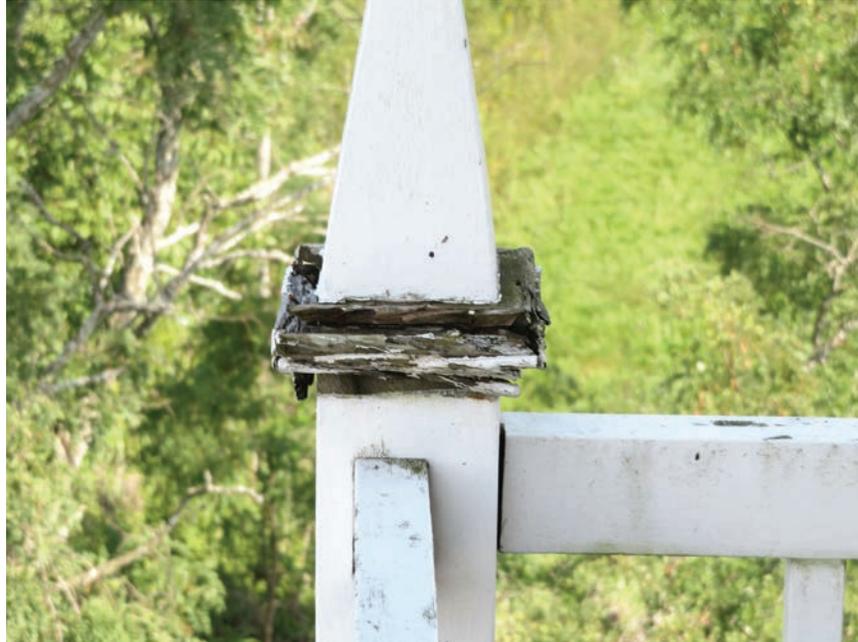
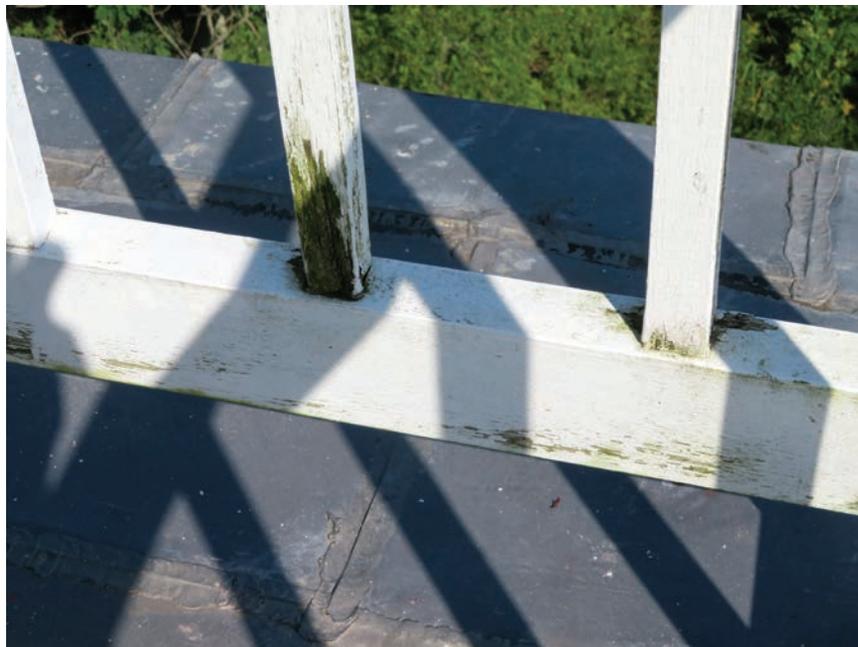
The applied molding on the four corner posts of the railings at the belfry are of different wood than the rail and posts themselves. The applied molding appears to be pre-milled white pine, while all other components of the rail are custom cut from a more durable wood. The applied moldings have all failed, but the rail is in excellent condition with the exception of the deterioration of the one baluster. JGWA, 2020.

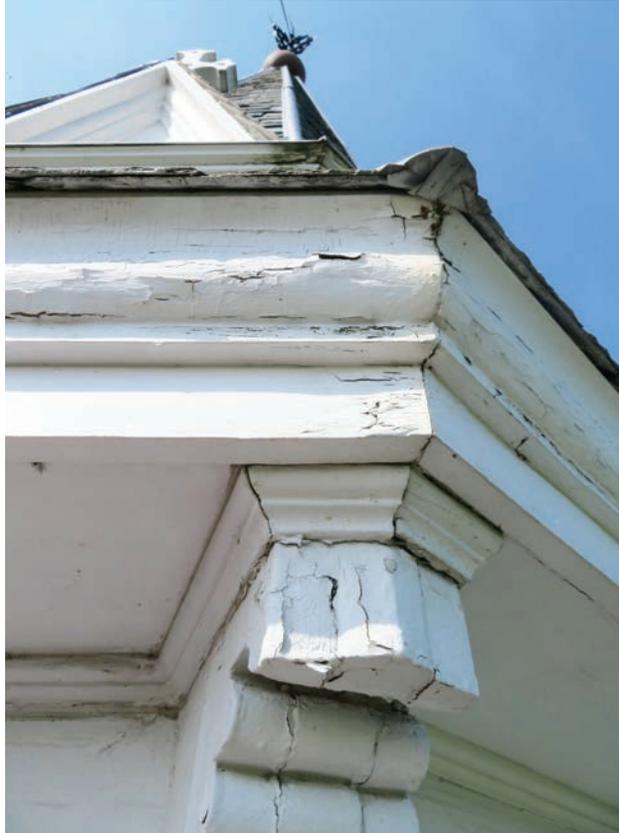
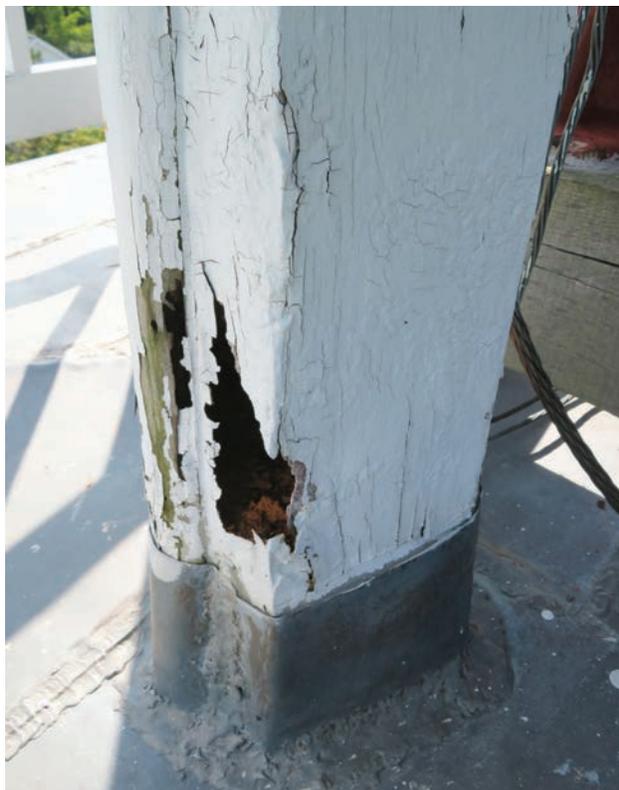
The starter course of slate does not project adequately beyond the edge of the tower's cornice. This has led to paint failure and some minor deterioration of the wood just below the slates. The lack of counter flashing above the base flashings located at the bottom of the eight posts that support the belfry has led to water damage to the posts. Three of the posts show advanced signs of wood rot. JGWA, 2020.

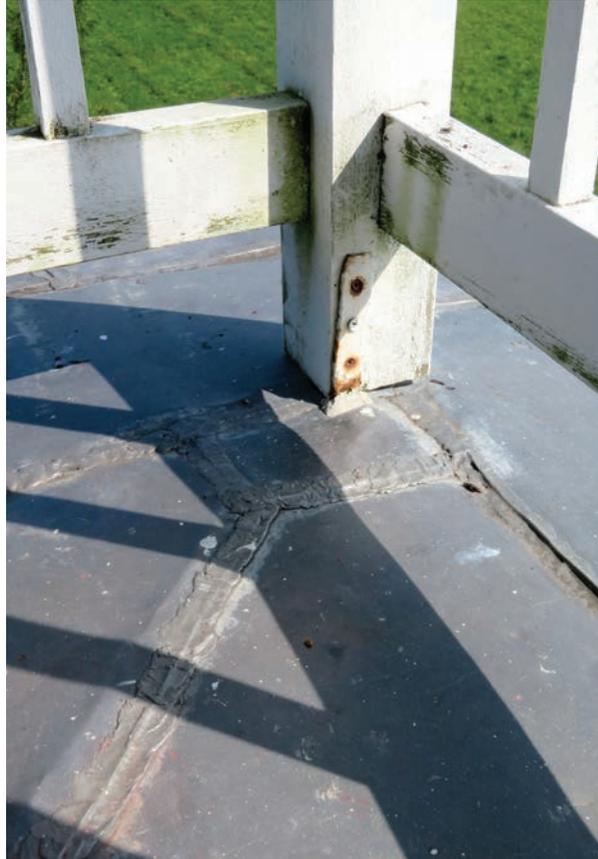
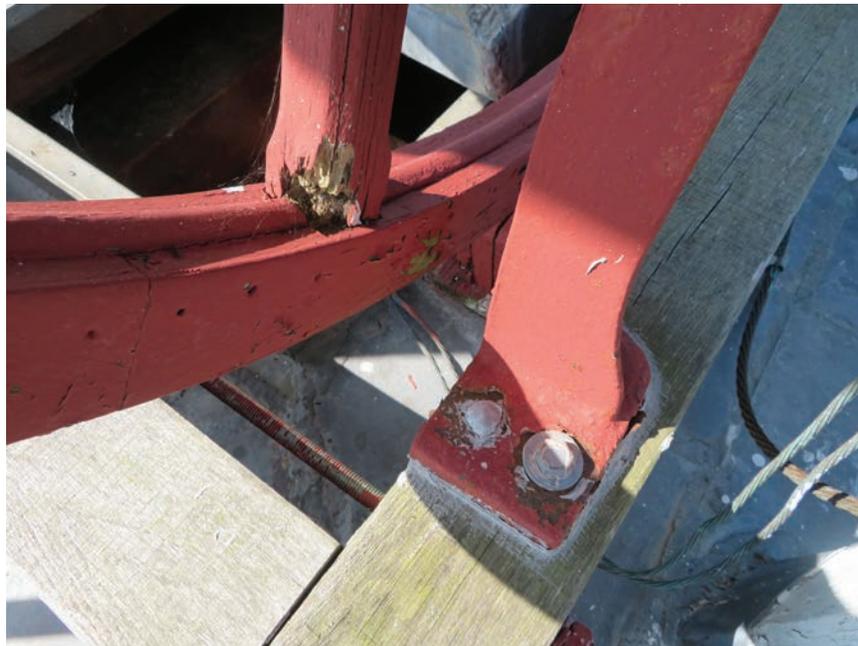
The flat seam metal roof of the tower (left) is in good condition, but is penetrated at four locations to anchor the rail. This connection relies on caulk joints to remain watertight. Some of these joints have begun to fail. The bell rope pulley (below) is deteriorated in some locations. Caulk has been applied to open joints in the past, but expanding rot will lead to greater water ingress and deterioration. JGWA, 2020.

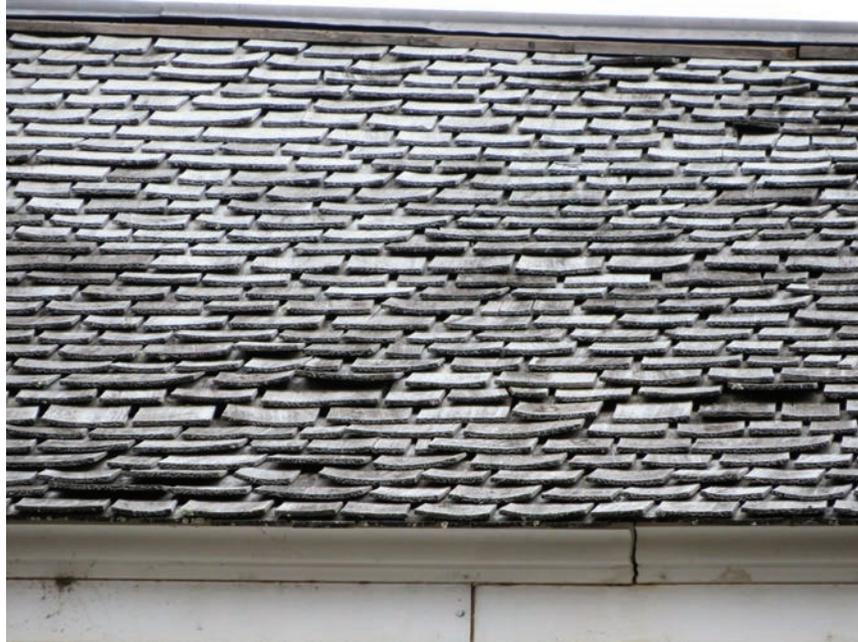
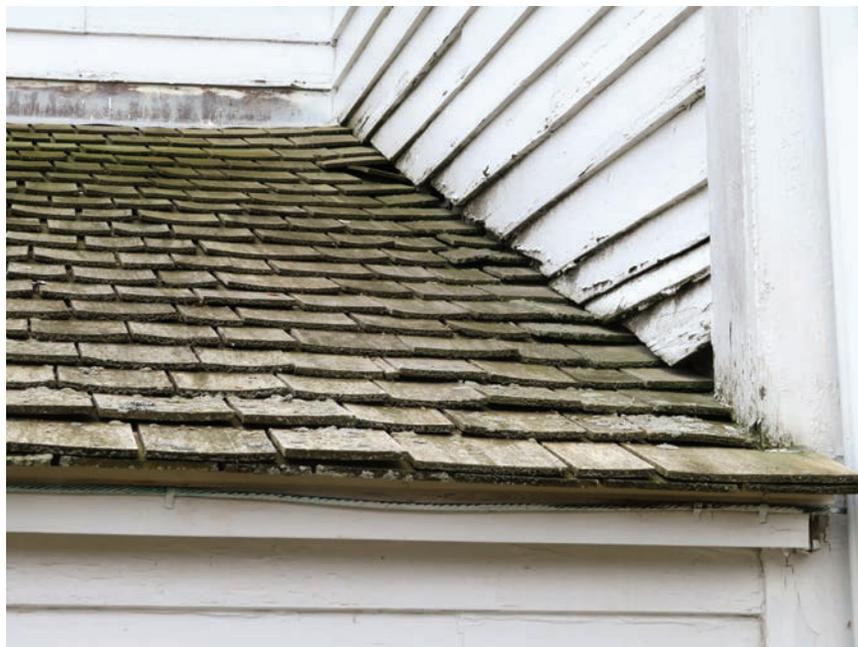
The wood shingle roofing above both the main church and the furnace room show signs of warped and split shingles. While the shingles on the south slope of the roof show greater warping and cupping, those on the north are covered in more biological growth. Where the lower roof engages with the wall of the church, the clapboards are deteriorated. The flashings at the chimney are also a source of water entry into the furnace room. JGWA, 2020.

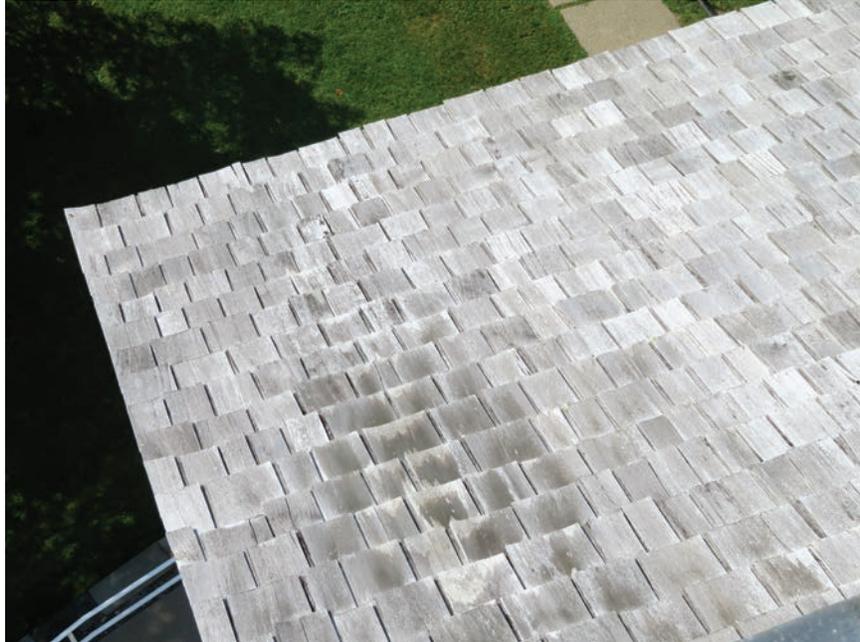
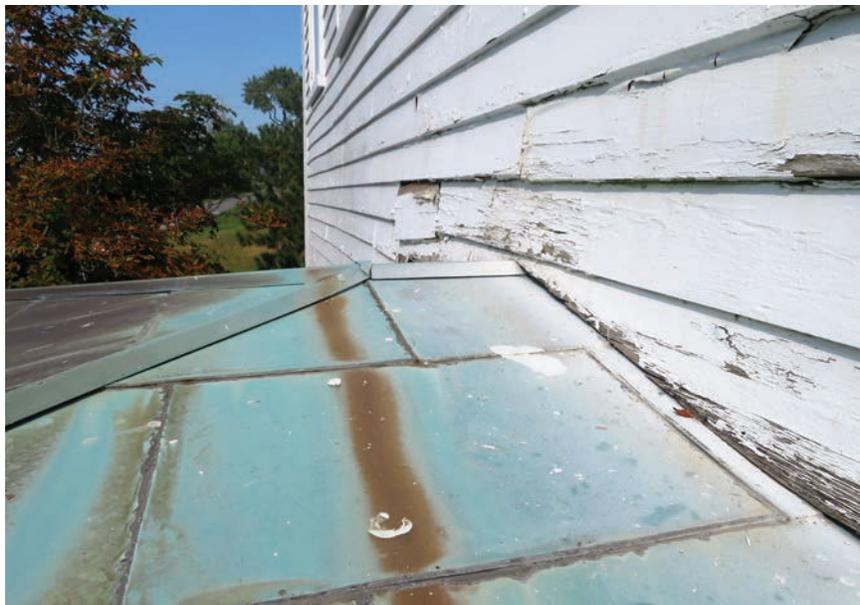
Roof water, falling from the tower roof to the shingles below, has led to greater deterioration of the wood shingles in those areas (upper image). Both the copper roof of the entry porch and the adjacent clapboard siding shows signs of water splashback from the roof above (lower image). JGWA, 2020.

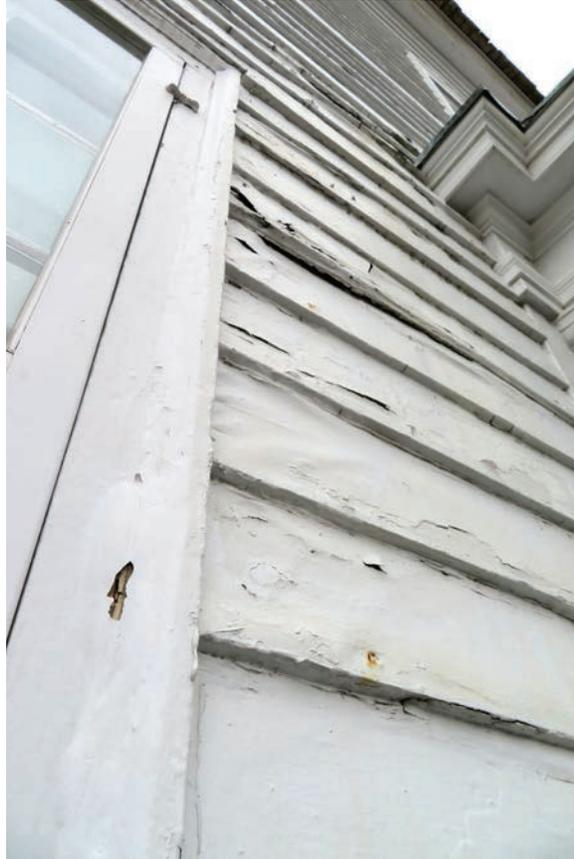
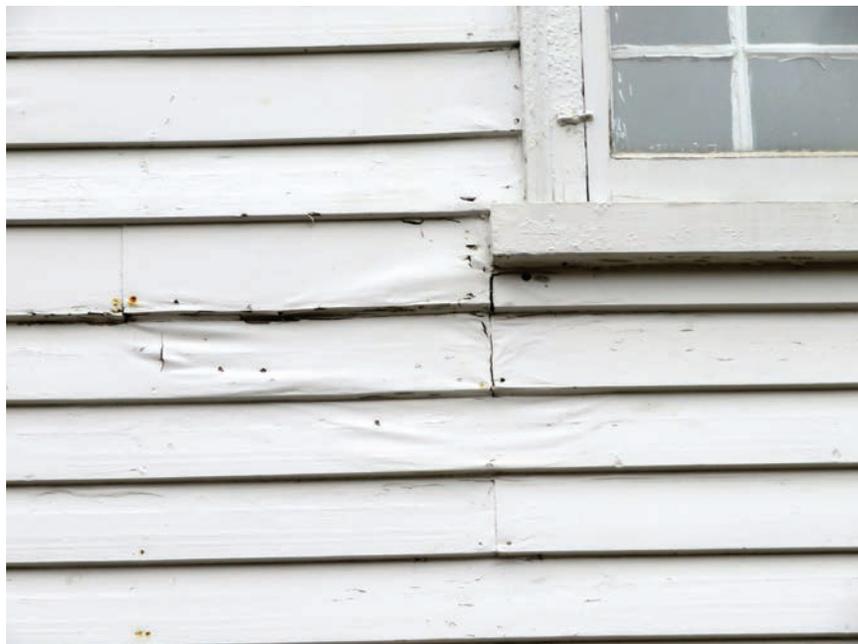
Paint failure and underlying wood rot and deterioration of wood siding and trim are the most widespread problem conditions at Christ Church. These conditions tend to be the result of uncontrolled water runoff, open joints, or poor repairs, as well as inferior quality materials. Moisture transfer from within the building is also a likely contributing factor. JGWA, 2020.

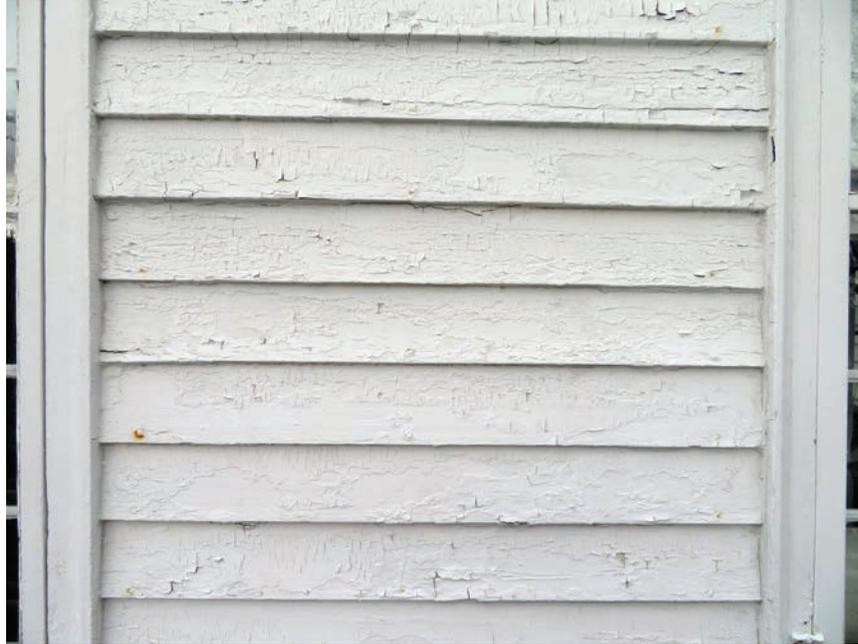
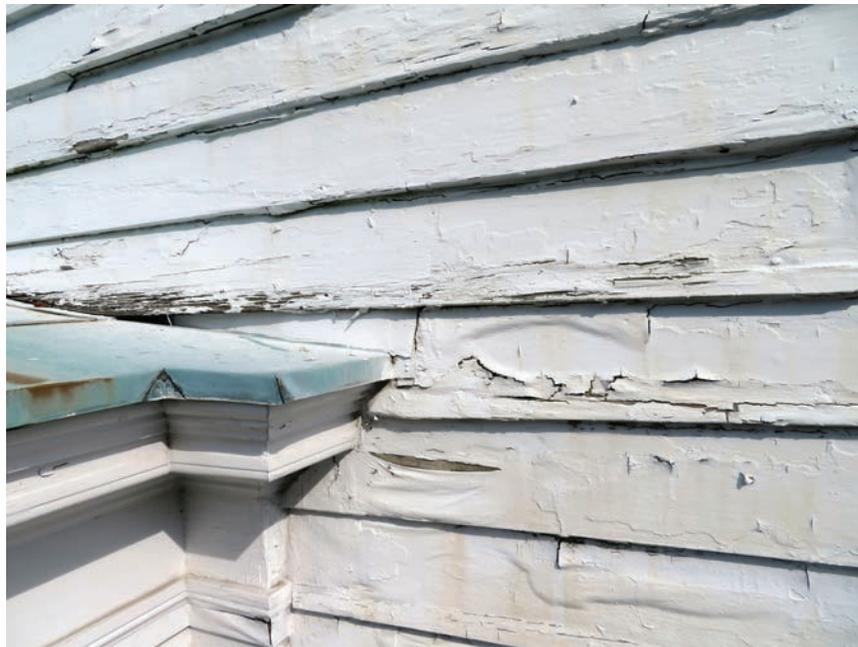
Uneven paint buildup and isolated areas of paint failure are common issues for a building of Christ Church's age. Areas where large sections of paint are blistering to bare wood, such as adjacent to the entry porch roof (lower image), are more problematic, as they allow water to be trapped behind the paint and indicate high moisture content in the underlying wood.

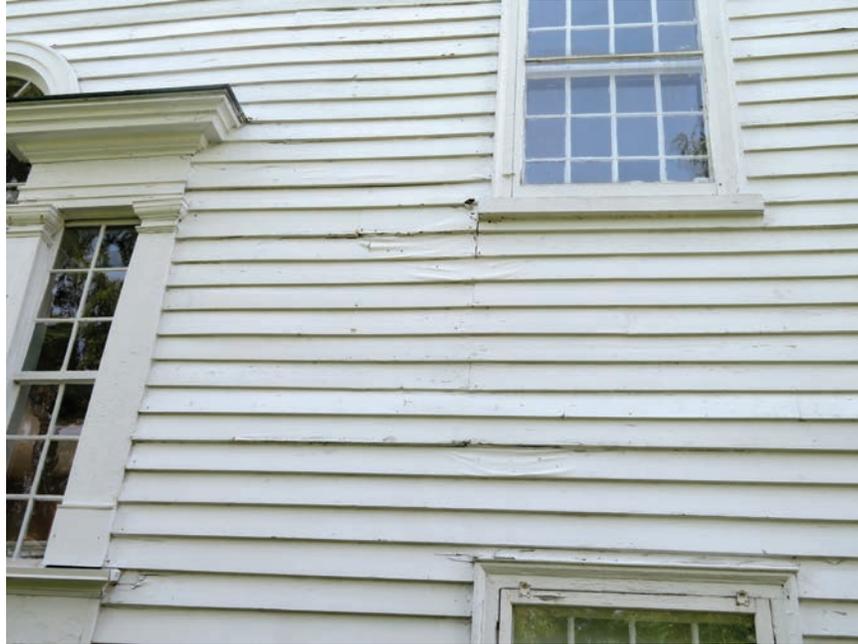
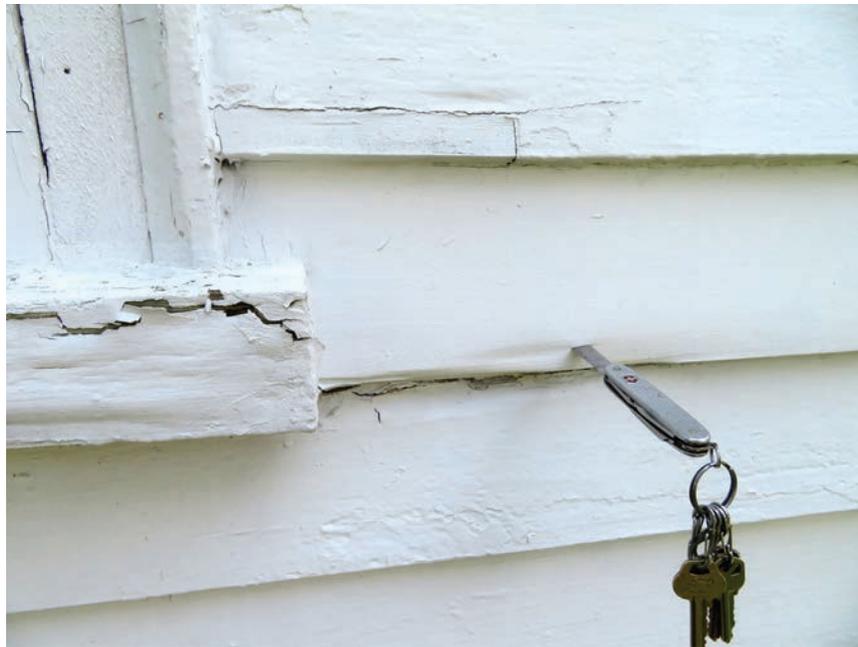
A substantial area of deteriorated wood exists between the three windows shown in the upper image, which is located on the west end of the church's north wall. The full extent of this damage may not be known until removal of the siding, but significant outward signs of deterioration are present. In some locations, intact paint masks areas of rotted wood siding and trim. JGWA, 2020.

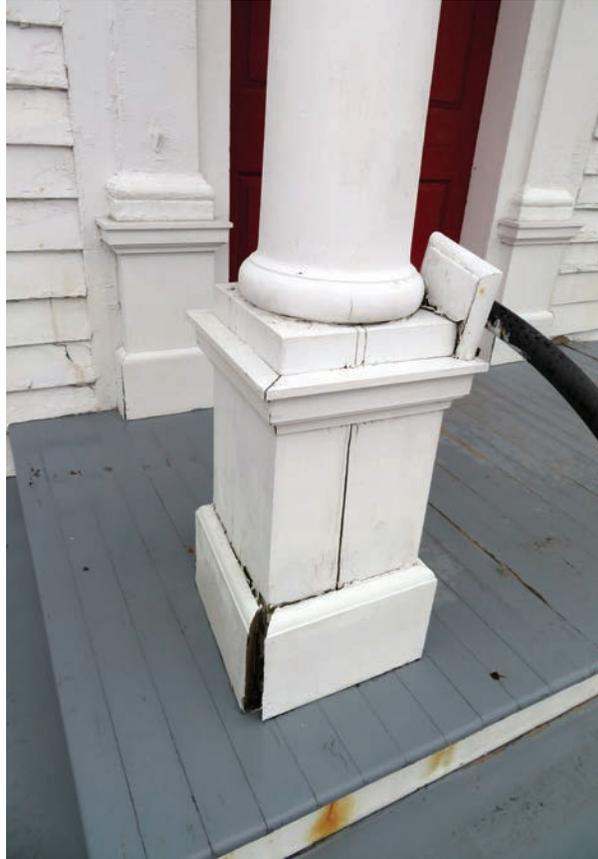
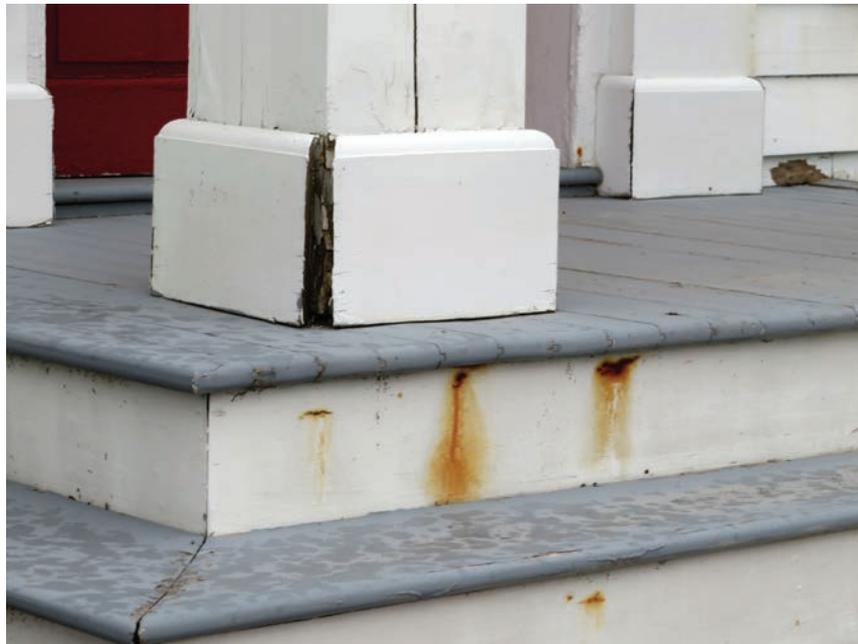
While the opening of joints between two pieces of wood is one of the reasons for the widespread deterioration of siding and trim, most of these joints have been patched in the past to mask the poor underlying condition. On the entry porch, visibly open joints have not led to the same deterioration because the wood used is of better quality, and water that enters has been able to get out. Note the rust staining where water has caused deterioration of underlying nails. JGWA, 2020.

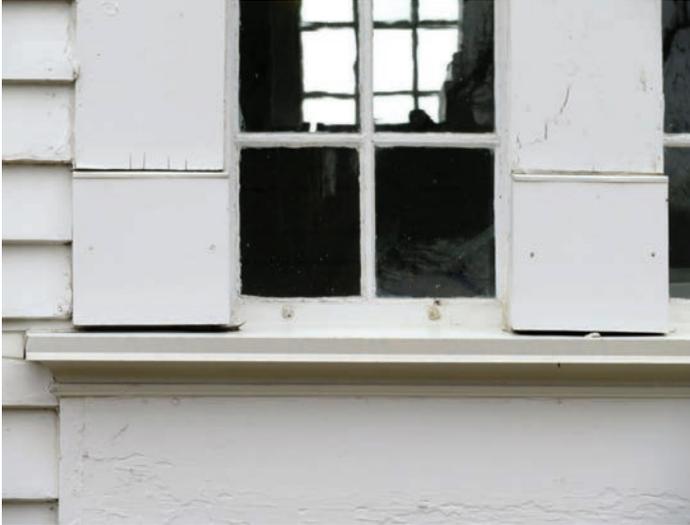
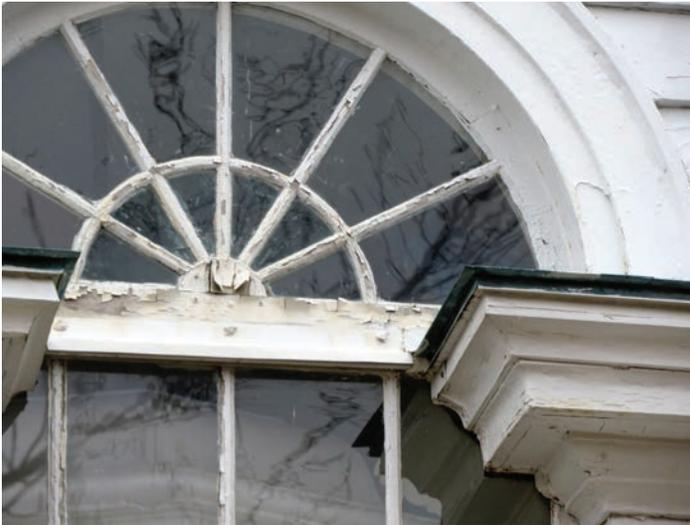
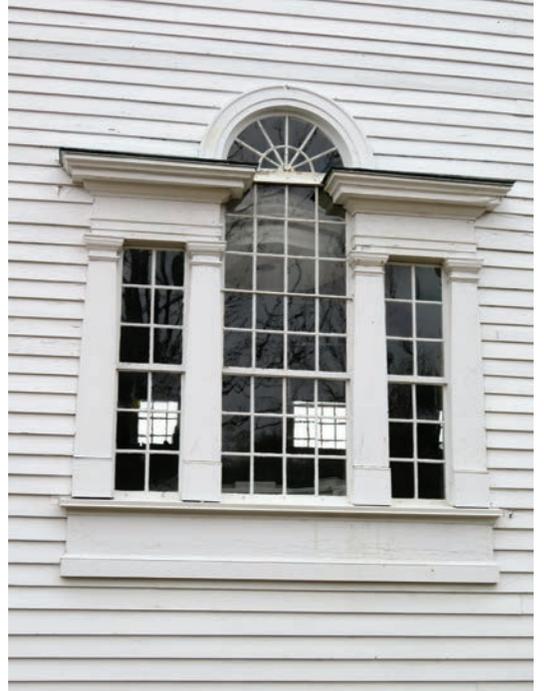
- When the Palladian window on the north wall of the building was originally installed, the molding profiles on its interior and exterior faces were identical. Due to deterioration and subsequent replacement, some of the moldings and the bases of the external pilasters no longer match those on the interior. This has adversely impacted the architectural appearance of the window's exterior.

The Palladian window on the north face of the church is the most architecturally refined feature on the exterior of the church. Its original design was altered when repairs were made in the recent past. The molding profiles on the exterior of the window originally matched those on the interior. The new plinth blocks, moldings, and aluminum flashings are not in keeping with quality of the original materials or the architectural intent. JGWA, 2020.

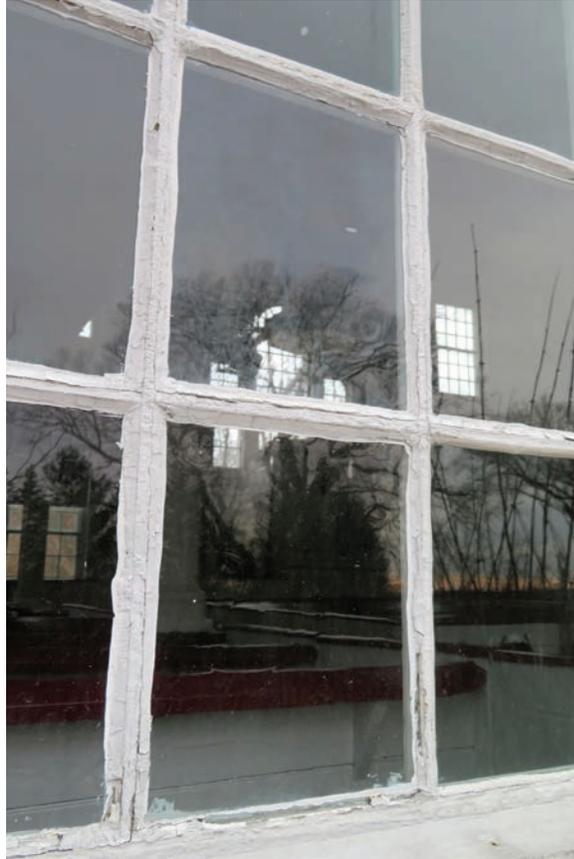
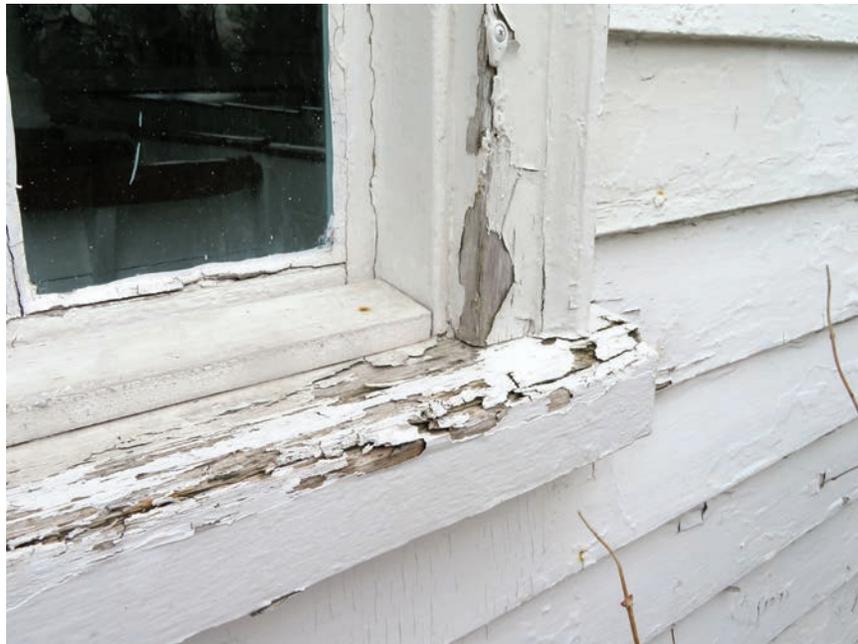
The double-hung (12-over-12) sash windows are one of the most important, and historically significant, architectural features at Christ Church. Where they are protected by later wood storm windows, these now 220-year-old twelve light sashes are in sound condition, but are not without problems. Failing and poorly applied glazing compound is the most prominent of these conditions. The window frames are more exposed than the sash and their typical level of deterioration is greater, as can be seen below. JGWA, 2020.

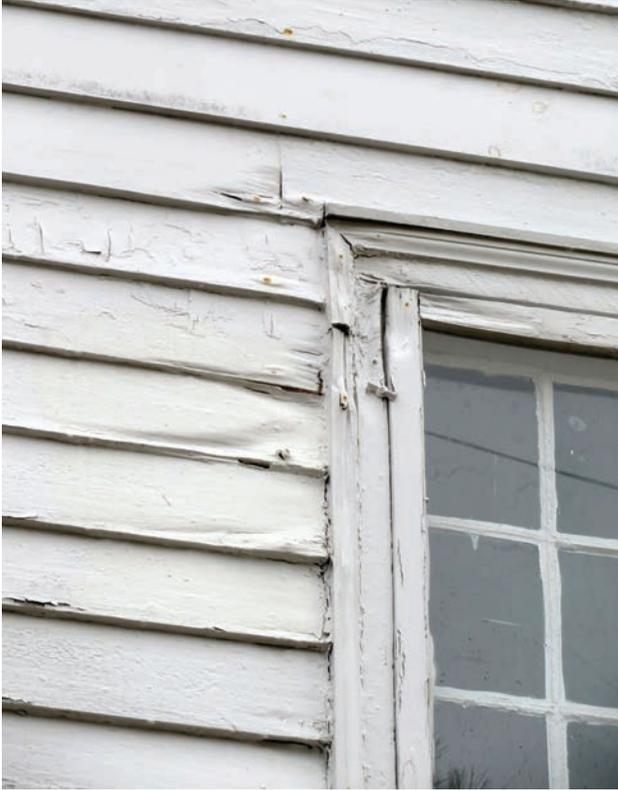
Clapboards, window frames, and exterior storm sash are all directly exposed to weather, and exhibit severe deterioration in some locations. JGWA, 2020.

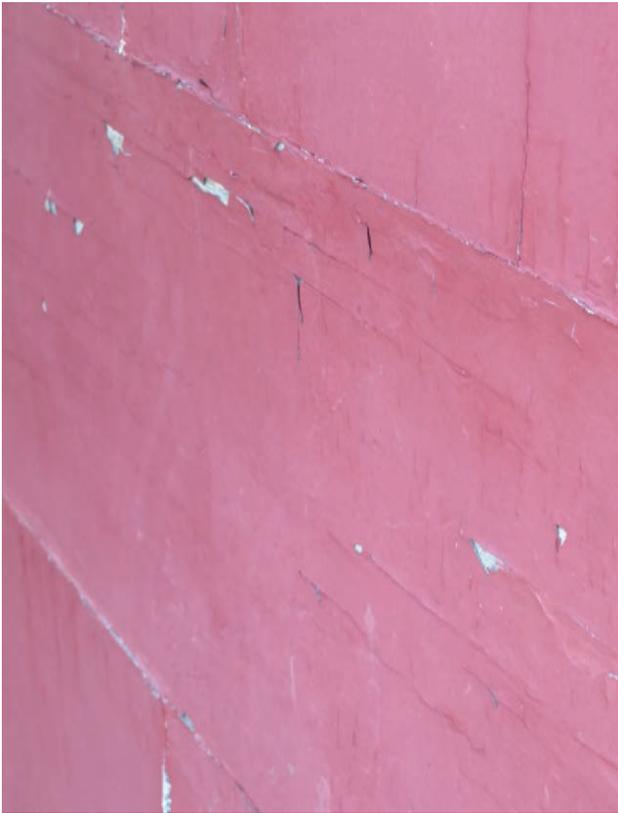
- The paint coatings on the front door and on the door at the base of the tower are peeling. This condition is particularly pronounced at the base of the door.

Although the two early exterior doors have not experienced the type of deterioration shown above, their paint coatings are weathered, chipped and fading. JGWA, 2020.

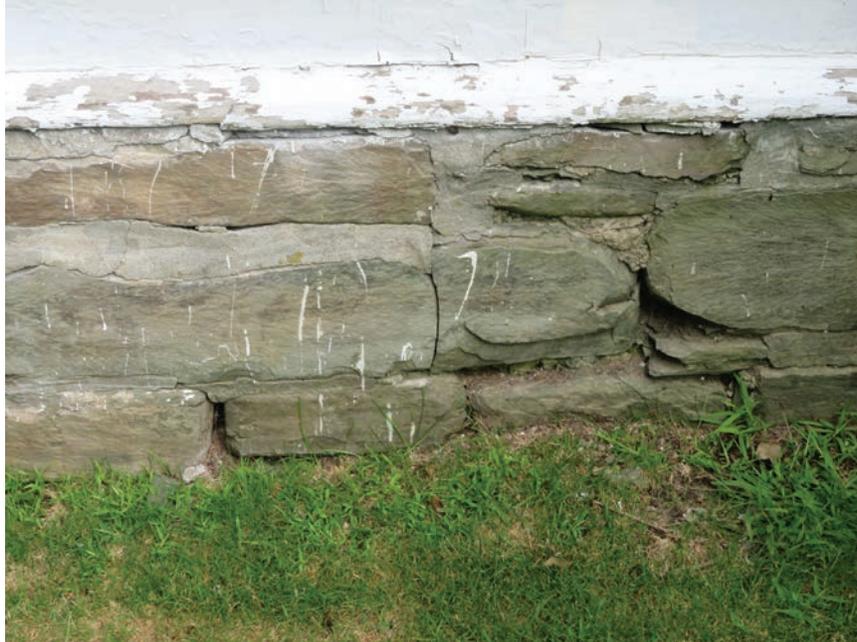
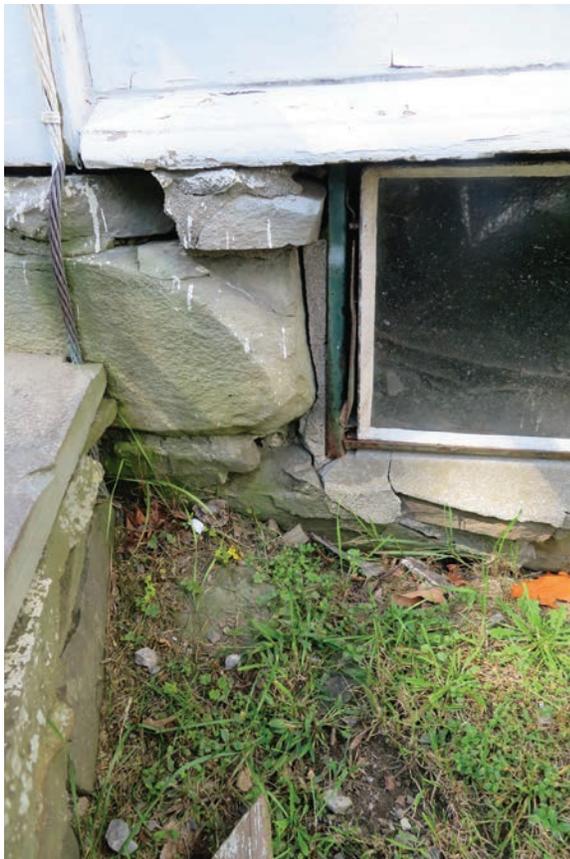
The church's irregular fieldstone foundation shows evidence of numerous repointing campaigns, as well as open and failed mortar joints. Isolated sections of movement and cracked or deteriorated stones exist in some locations. The church has no basement, only a very shallow crawlspace below the sanctuary. The depth of the footings is not known, but some evidence of cyclical movement does exist within the building. JGWA, 2020.

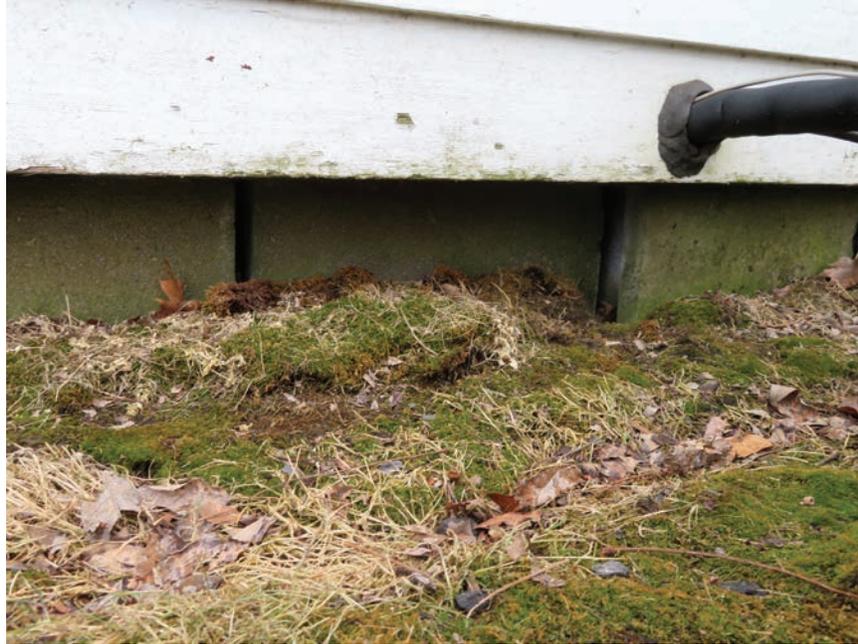
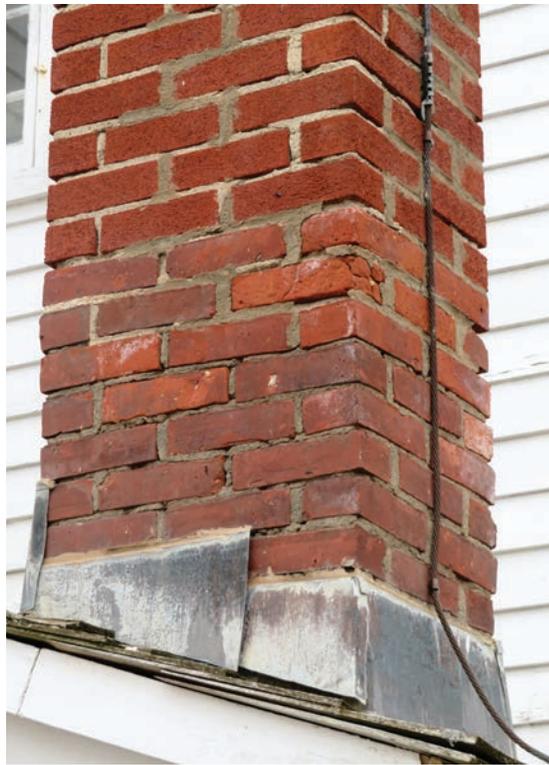
The furnace room is tucked between the main body of the church and the tower. It is of entirely modern construction that appears to be slab on grade with a single course of concrete block supporting the framed walls above. Along the north wall, the blocks have shifted dramatically out of position (above). Water enters the interior at these cracks because the slab is below the level of the exterior grade. The brick chimney (left) has been repaired and partially rebuilt in the past, but open joints, failed bricks, and mismatched mortar are all present. JGWA, 2020.

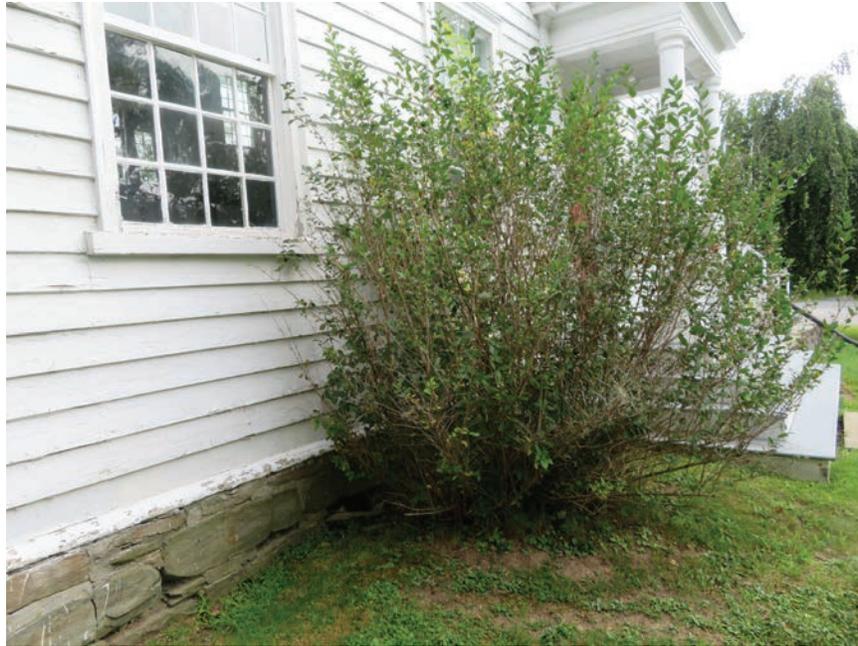
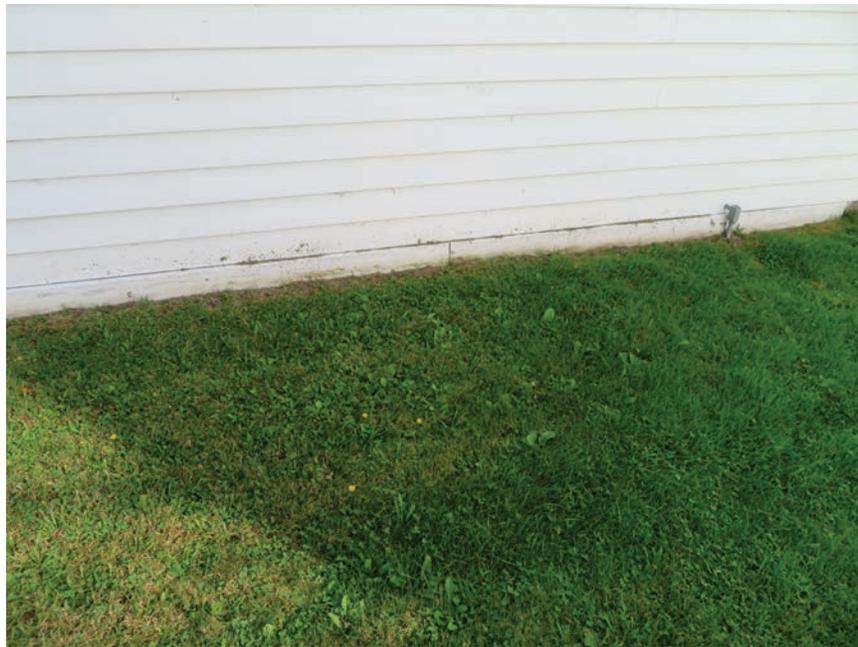
The lawn to the north of the church is higher than the sill board along much of that elevation. Although a swale has been created to divert surface water away from the building, it has not been entirely effective. On the south side of the building, the sill is well above grade, but areas of displaced stonework exist. The root system of the overgrown shrub against the south foundation may lead to additional displacement of foundation stones, and the plant holds moisture against the siding. JGWA, 2020.

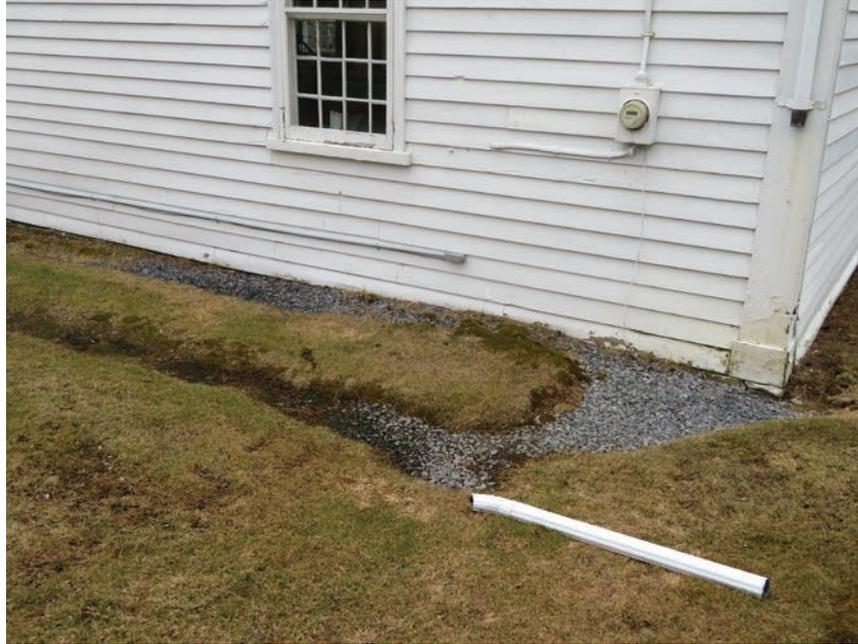
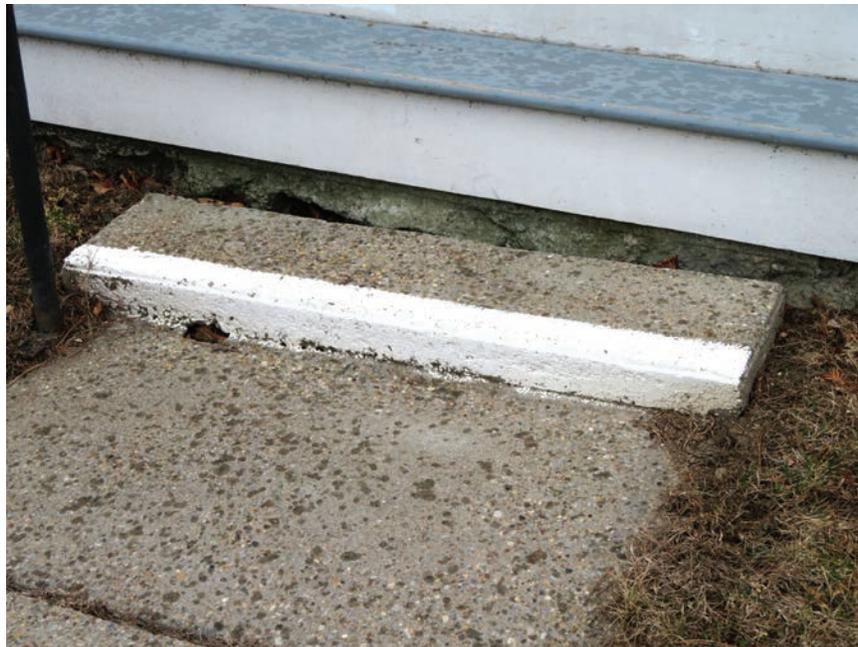
The detached roof leader pipe and gravel-filled swale on the north of the building (upper image) are indicative of a broad failure to effectively deal with roof water runoff on the north side of the building. The unevenly settled concrete walkway leading to the front door presents several trip hazards, such as the sunken step shown in the lower image. JGWA, 2020.

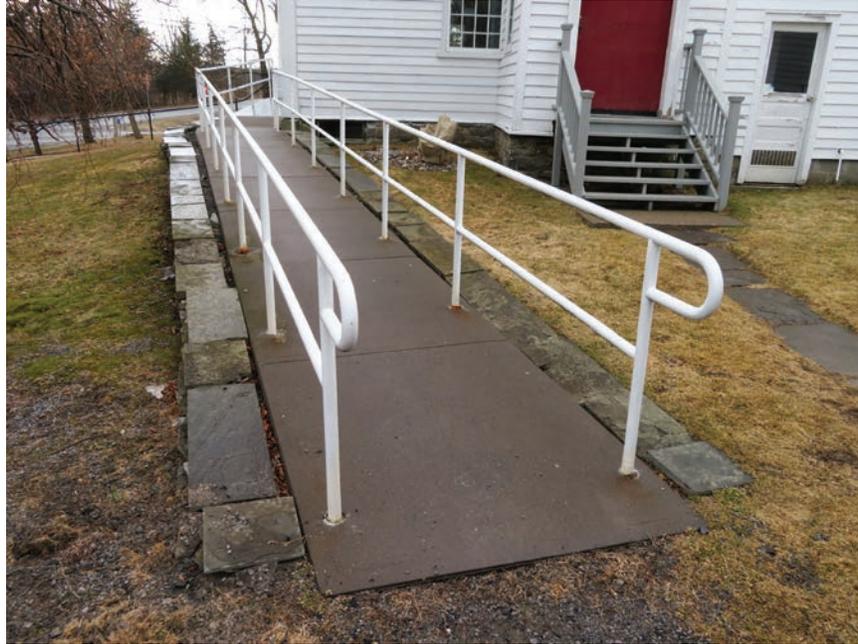
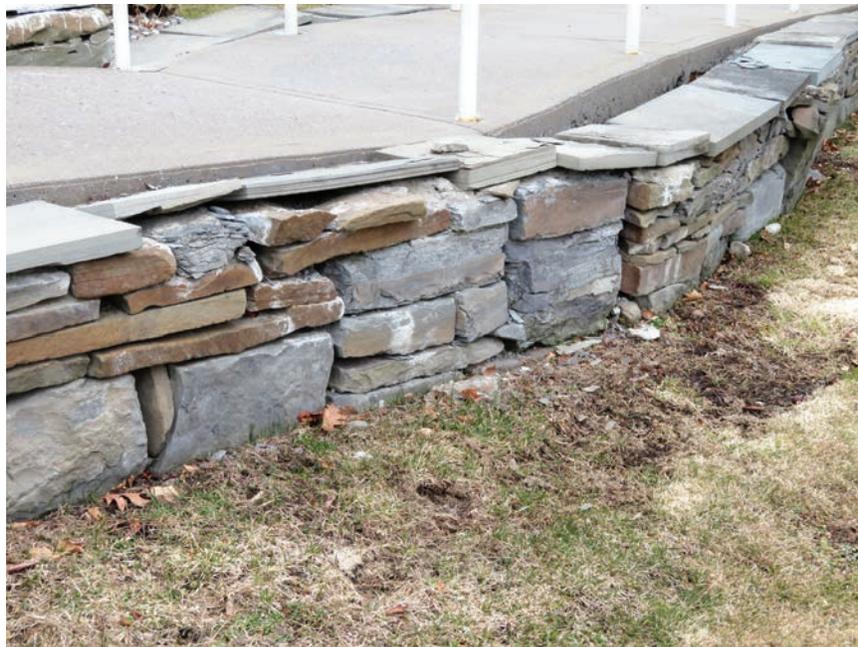
During the 1994 work, an ADA (Americans with Disabilities Act) compliant ramp was added to provide access to the main door to the church. The pipe rails are prominent and not in keeping with the character of the building. The abutting dry-laid stone wall has shifted, and subsequently failed in numerous areas. JGWA, 2020.

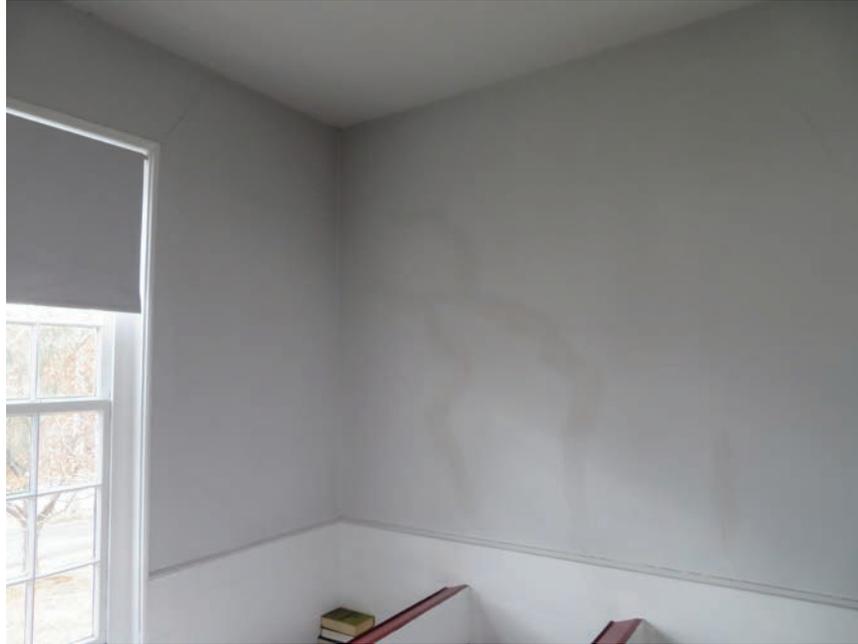
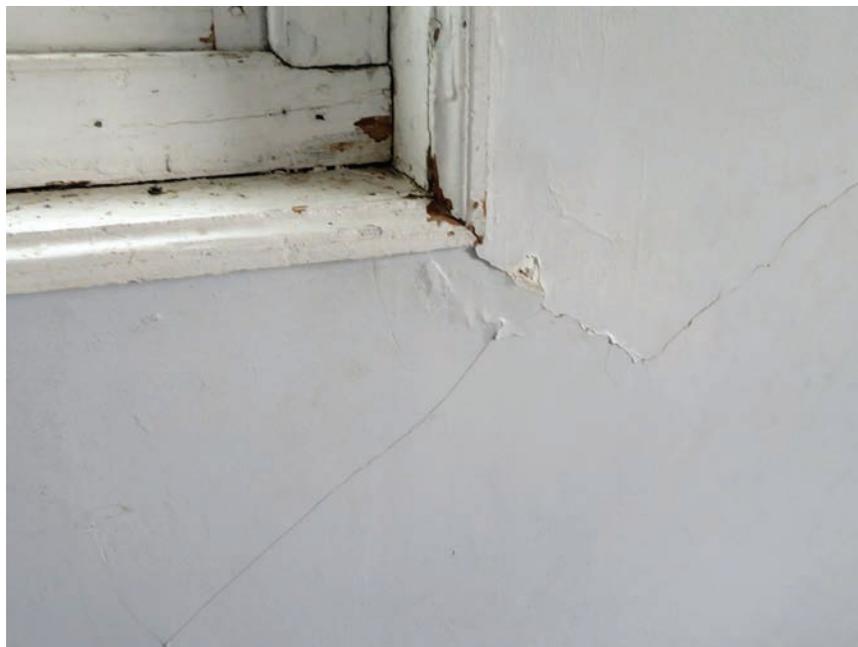
The interior of the church is used regularly, and is well cared for and maintained, but the impact of moisture and movement within the structure has led to widespread cracking of the plaster in both the walls and ceilings on all sides of the interior. These cracks typically extend from breaks in the wall surface, such as corners and wall openings. All of these cracks post-date the 1982-83 interior restoration. JGWA, 2020.
