CHRIST CHURCH DUANESBURG

EXISTING CONDITIONS REPORT

FEBRUARY 2021

JOHN G. WAITE ASSOCIATES, ARCHITECTS PLLC

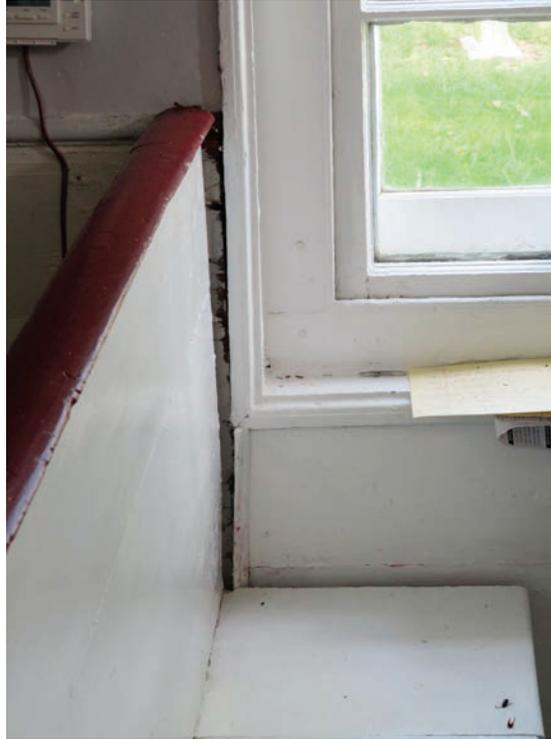
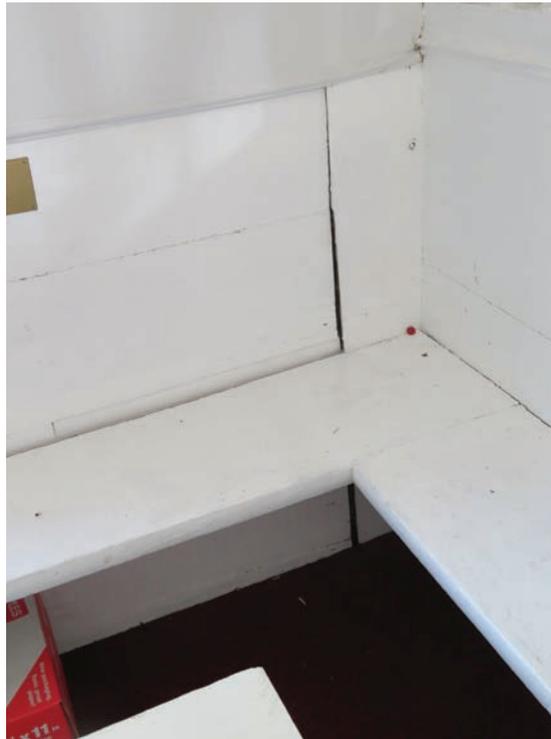
The interior movement indicated in the plaster can also be seen in the open joints and shifting panels of the box pews and other wood elements of the interior. The out-of-level condition of the gallery rail and flooring also indicate settlement of the structure. JGWA, 2020.

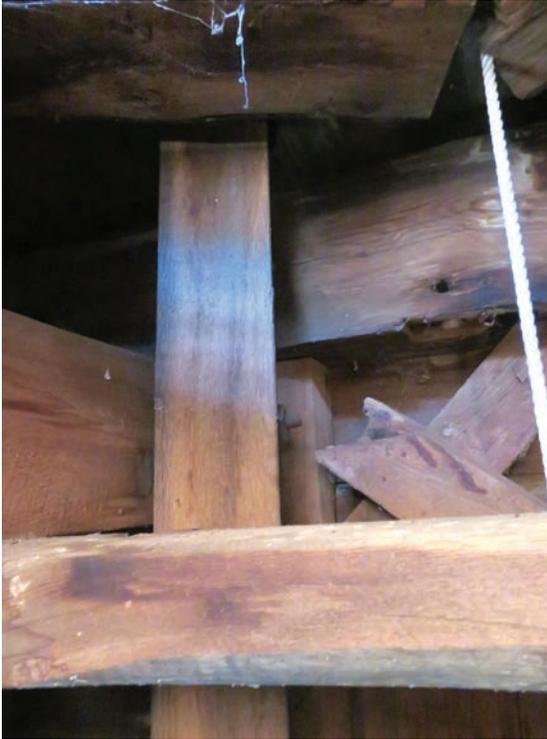
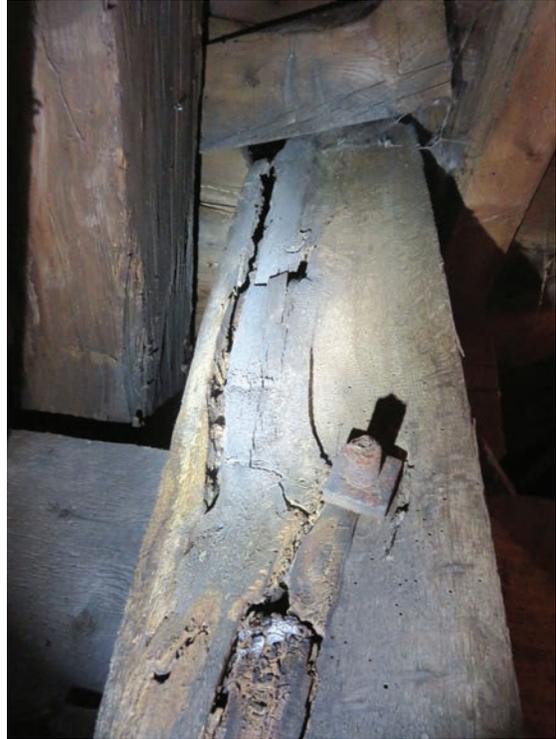
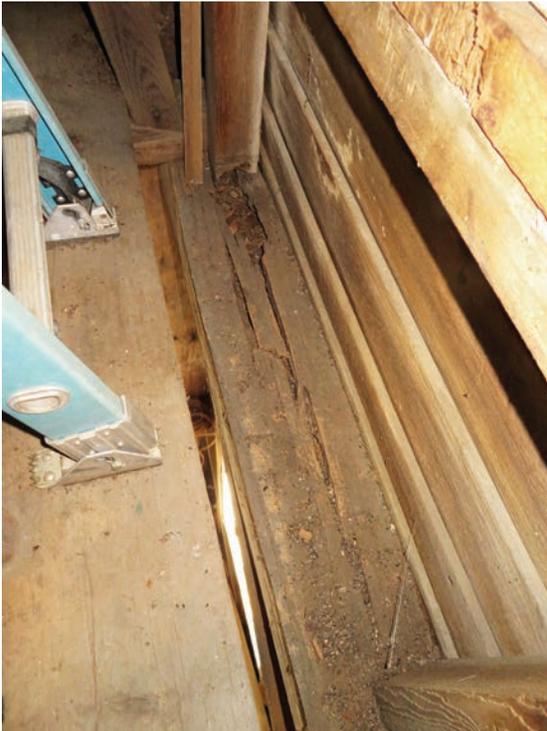
Past water entry has led to three observable areas of significant wood rot and failure within the tower. Both of the upper images show conditions on the north side of the tower that relate to deterioration of the posts supporting the belfry. The lower left image shows a beam on the east wall of the tower that relates to past water entry at or adjacent to the window above. JGWA, 2020.

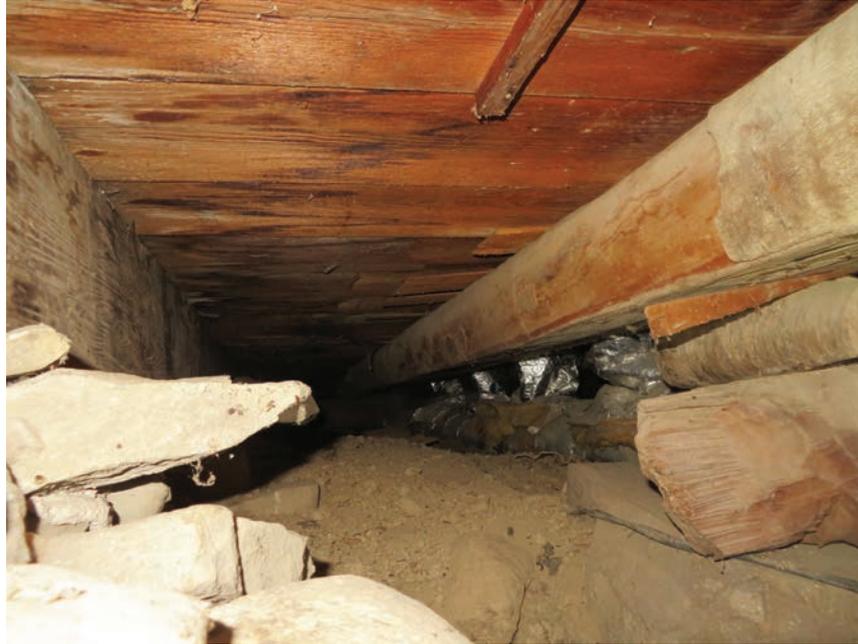
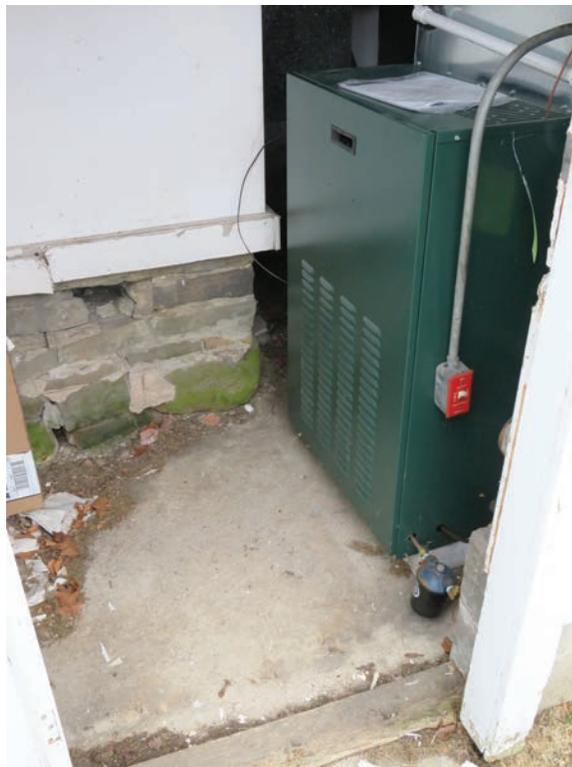
The crawl space below the church is high enough to accommodate the ducts needed for the hot air heating system, but not much more. There is no vapor barrier at the level of the dirt floor. The sleepers and sills rest on a series of cribbed and shimmed piers, which likely have no below grade footings. The concrete slab below the furnace has shifted, resulting in a low spot adjacent to the church's foundation. JGWA, 2020.

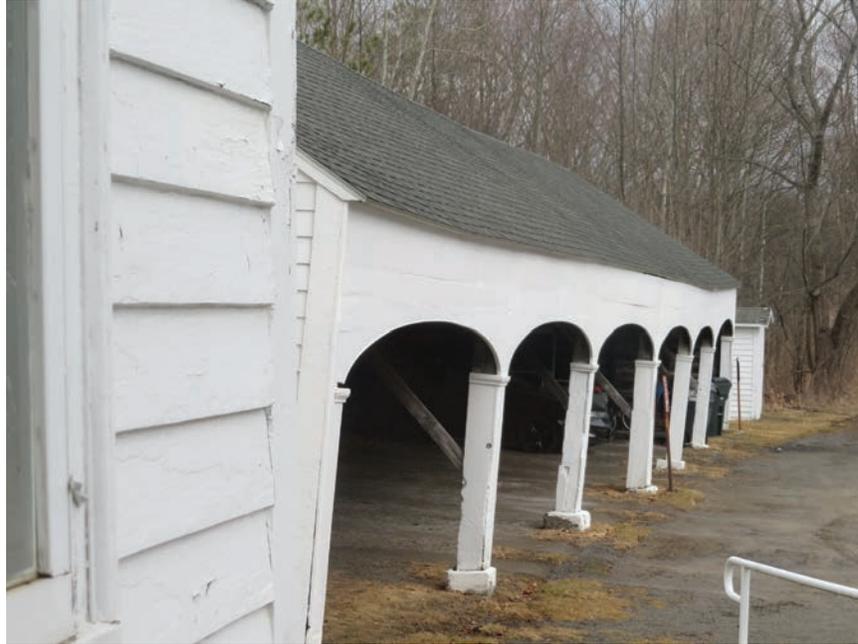
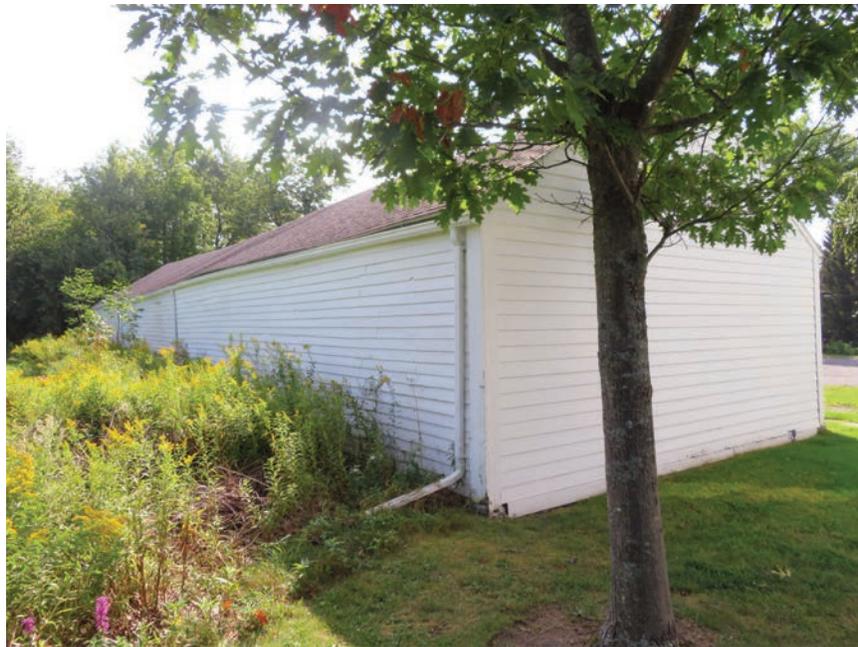
The six-stall carriage shed was originally twice its current length, and is a rare and important surviving example of this building type. Throughout its existence, the shed has been subject to cyclical movement and shifting of its frame, which in places is badly out of plumb. Numerous repairs have been made over time to address and shore up the building. Water based deterioration at the base of the sills and posts are the greatest threat to the structure of the shed. JGWA, 2020.

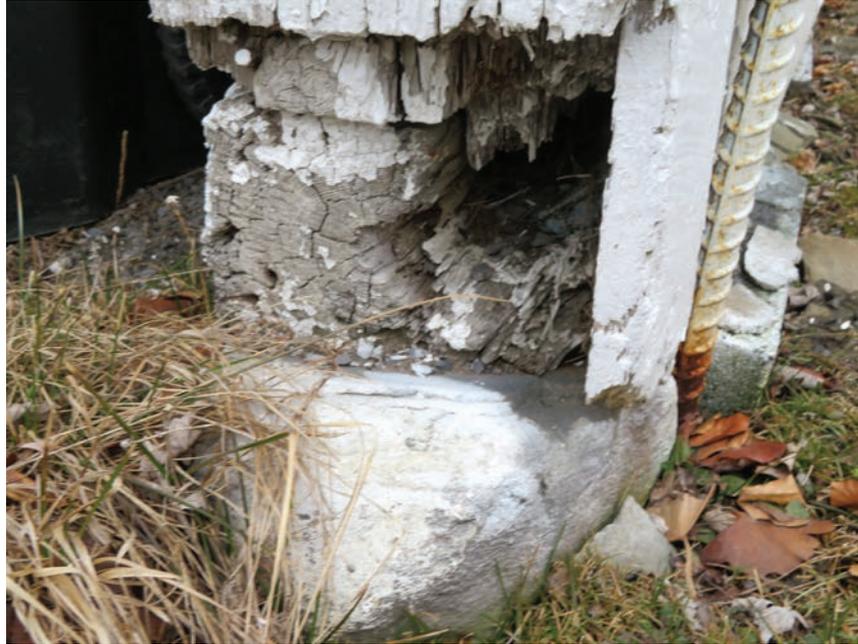
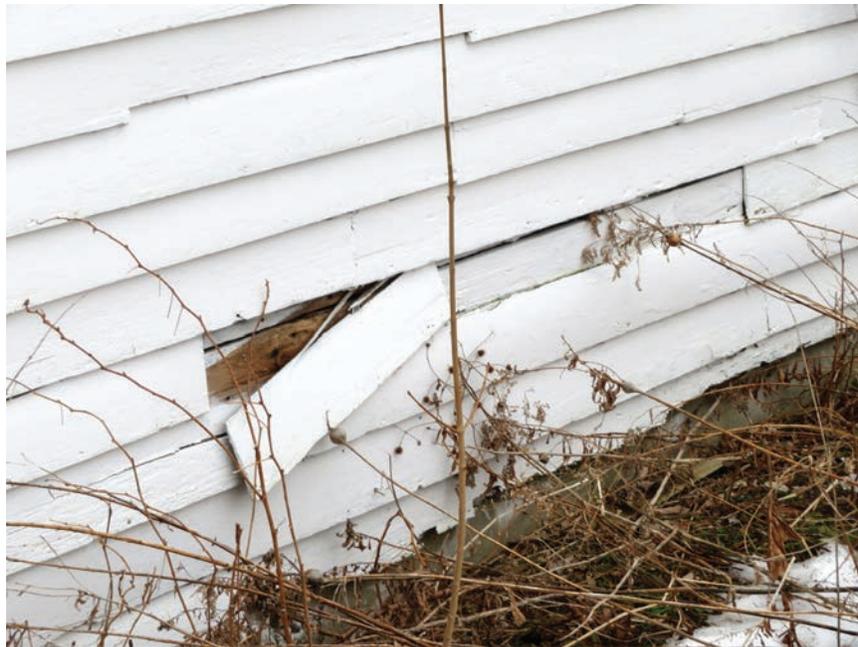
Exposed end grain of both posts and sills (upper image) pose a significant threat to the long-term preservation of the carriage shed. Adverse site and roofing conditions that do not adequately shed water away from the building can also undermine the long-term care of the building. The lack of an overhanging eave or gutter on the north side of the shed has led to failure of some areas of the siding (lower image). JGWA, 2020.

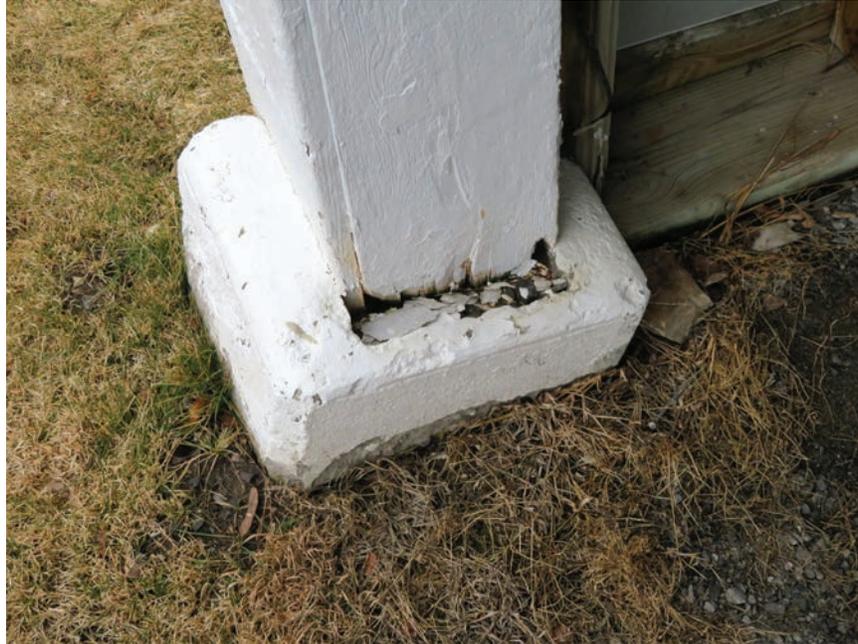
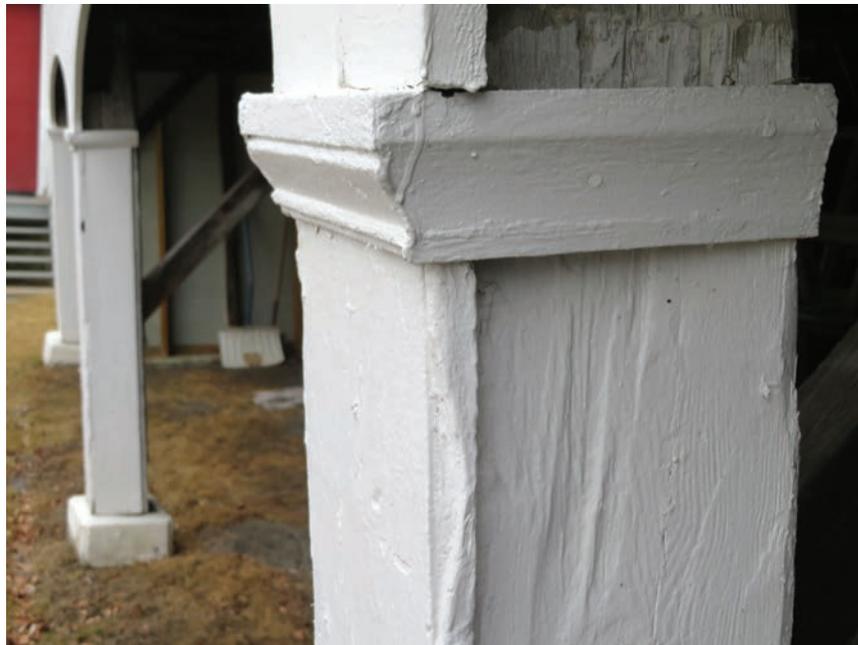
Movement of the posts along the south wall of the carriage shed has caused the significantly out-of-plumb condition on that elevation. Poured concrete plinths exist below each of these posts, with some of the plinths poured directly around the bottom of the wood post. The resulting recesses can trap water and cause wood rot. The lower image shows one of many instances where the original cladding of the posts is missing. The trim on the side that lacks the original cladding is a later replacement and does not match the original trim that remains on the primary elevation. JGWA, 2020.

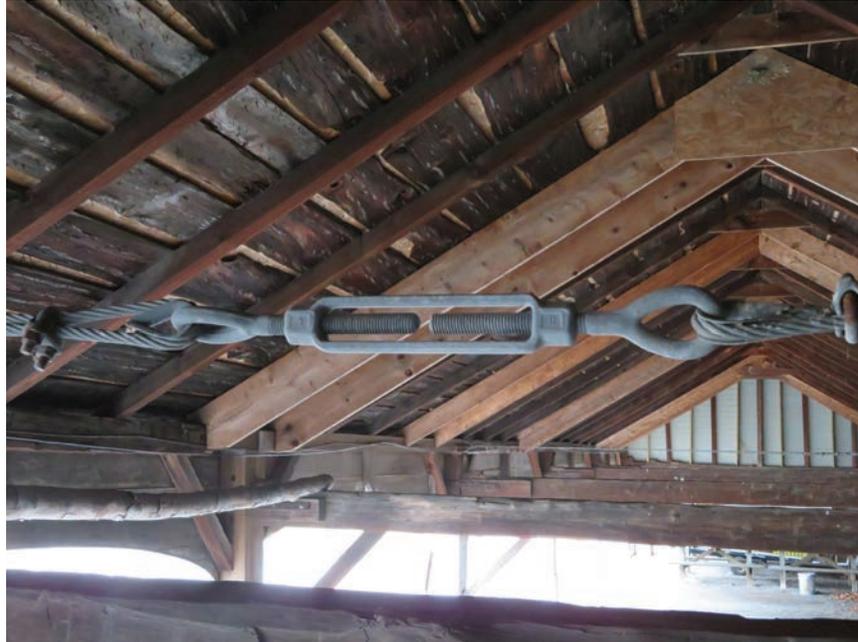
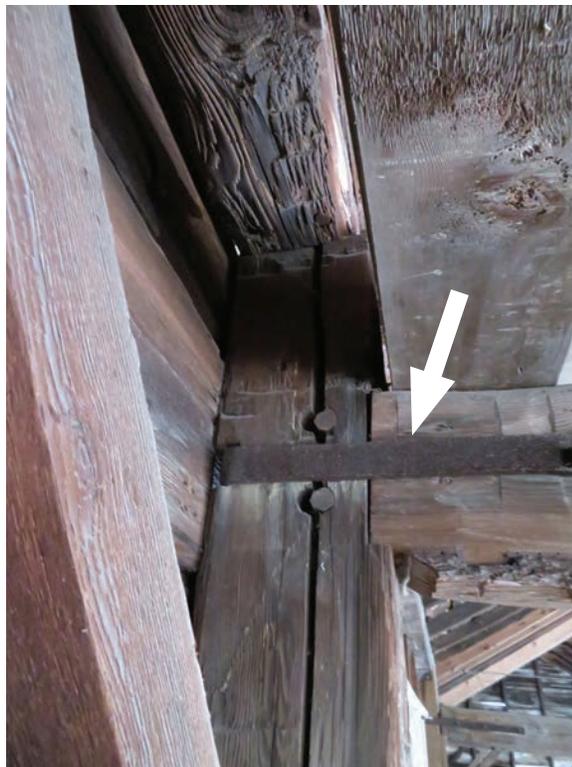
Metal cables and turn buckles were installed to counteract the outward thrust of the rafters, because the shed's roof structure lacks collar ties. The resulting forces exerted on the rafter plates led to cracks in some of the posts along both the north and south walls of the shed. In these locations, metal braces were installed to reinforce the connection between the beams and the cracked posts. JGWA, 2020.

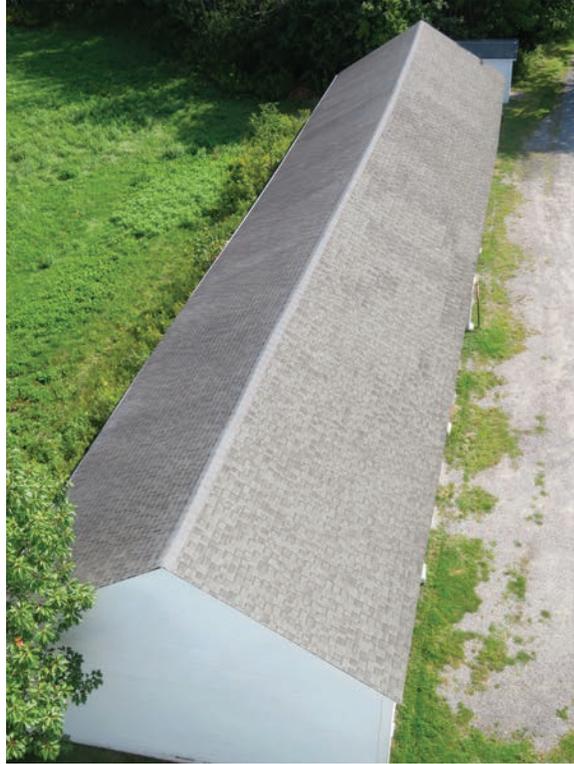
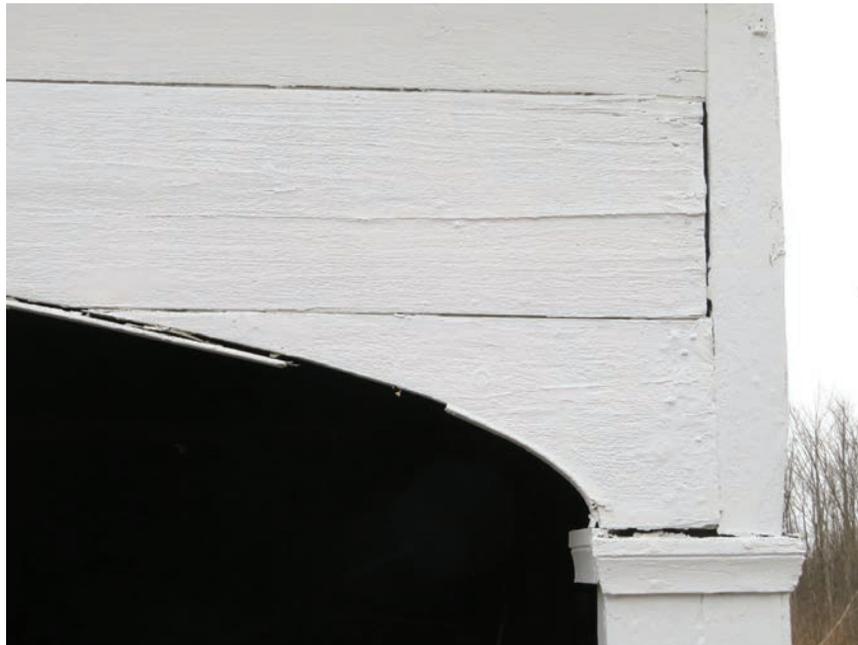
Although the roof of the carriage shed has been replaced in recent years, and remains in good condition, there is water damage to the wall cladding on both the north and south walls. This condition is in part because the slight overhang of the eaves offers little protection to the wall below. A gutter exists on the rear wall, and the existing deterioration may predate that. Open joints in the siding, along both elevations, allow for water to access the wood framing behind. JGWA, 2020.

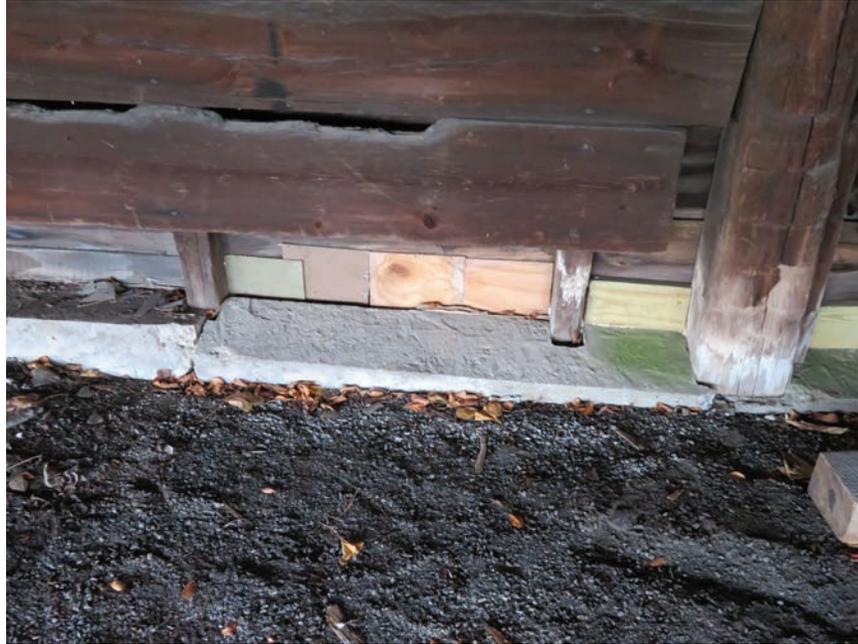
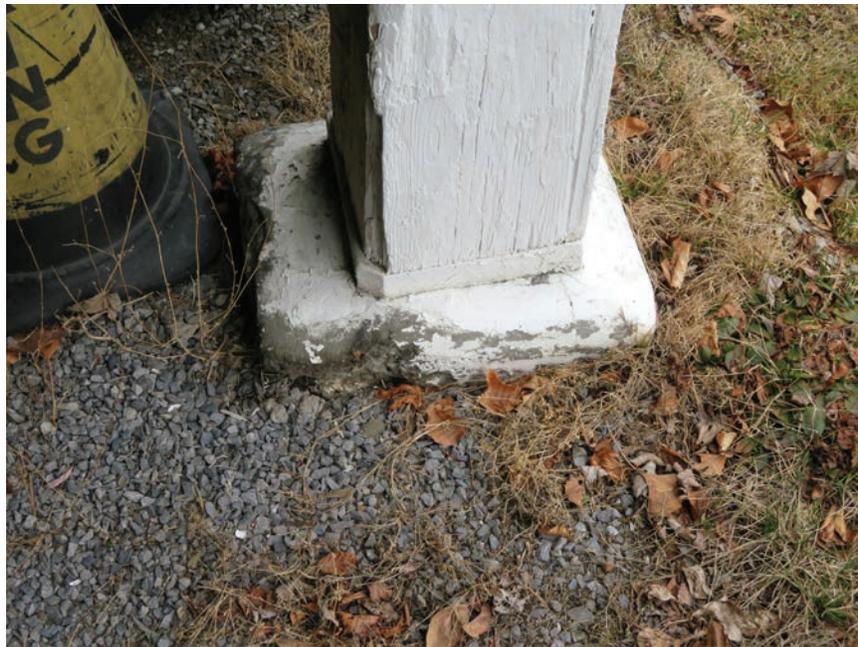
Moisture migration, as a result of capillary action, is a significant threat to the preservation of the carriage shed. In most wood structures, horizontal sills help to protect the posts, as moisture does not travel across grain nearly as freely as it travels along the grain. In the lower image, a thin piece of wood is laid horizontally, interrupting water migration up the end grain of the post. JGWA, 2020.
